# Your Lift Health Assessment Report

Unit Number: XYZ123

## Car Doors

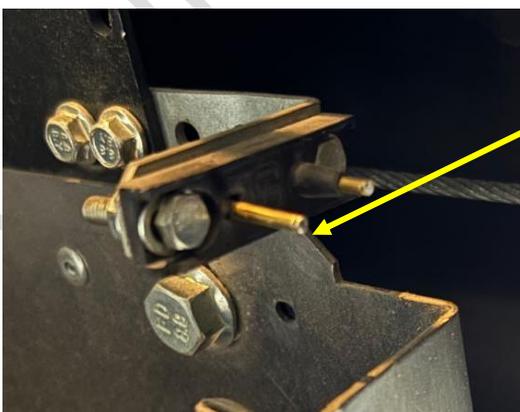
Figure 1A:

Car door gate contact exposed, part worn see 1A
LANDING DOORS

One metal prong for the car door contact is completely exposed. Electrical hazard & Risk of component failure and elevator breakdown.

POA (Plan of Action):

Part identified, car gate contact to be changed and tested, eliminating all risks.

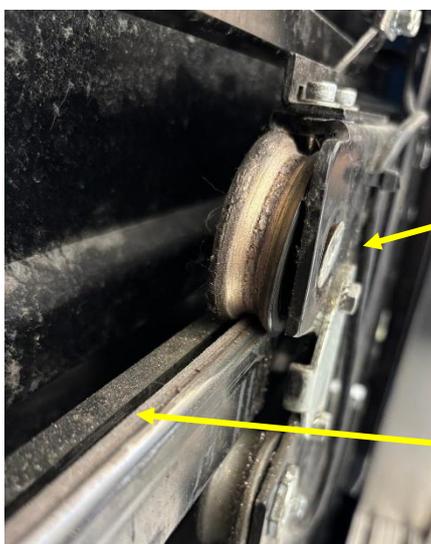
Figure 2A

HANGAR ROLLERS		Rear roller nut missing roller is loose, car door shaking/noisy see 2A
CAR DOOR TRACK		Debris build up, recommend cleaned and removed for smoother operation see 2a

ISSUE: Nut missing behind roller causing shaky door and imminent breakdown from component failure

ISSUE: Debris on track affecting car door operation

SOLUTION: Change roller securing and tightening correctly

SOLUTION: Remove debris, clean track change rollers

Rear car door roller to be changed and to be secured and tightened correctly, change both rollers simultaneously to prevent excessive wear on one side. Clean track and remove debris, if all completed can guarantee smoother car door operation and less breakdowns via the car doors.
